# ADDITIONAL ARCHAEOLOGICAL INVESTIGATIONS AT EPPINGTON PLANTATION, CHESTERFIELD COUNTY, VIRGINIA

ADDITIONAL ARCHAEOLOGICAL INVESTIGATIONS AT  
EPPINGTON PLANTATION, CHESTERFIELD COUNTY, VIRGINIA

WMCAR Project No. 01-25

*AUGUST 21, 2001*

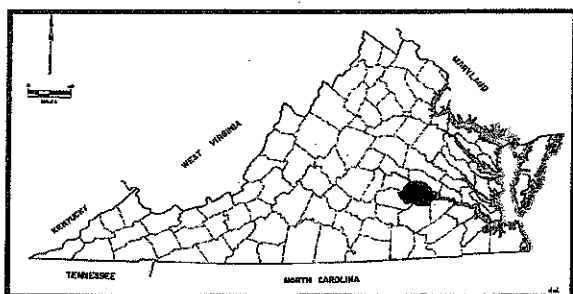
Figure 1. Project area location.

The William and Mary Center for Archaeological Research (WMCAR) conducted limited archaeological evaluation at Eppington Plantation in Chesterfield County, Virginia, from August 1 through 7, 2001 (Figure 1). The project area is located in southwestern Chesterfield County on the Piedmont Plateau about 840 m northwest of the Appomattox River (Figure 2). This evaluation was conducted at the request of Eppington Foundation Incorporated of Chesterfield, Virginia. The intent of the evaluation was to provide specific information concerning the nature of archaeological resources in the basement of the mansion and in the schoolhouse/kitchen area immediately west of the house.

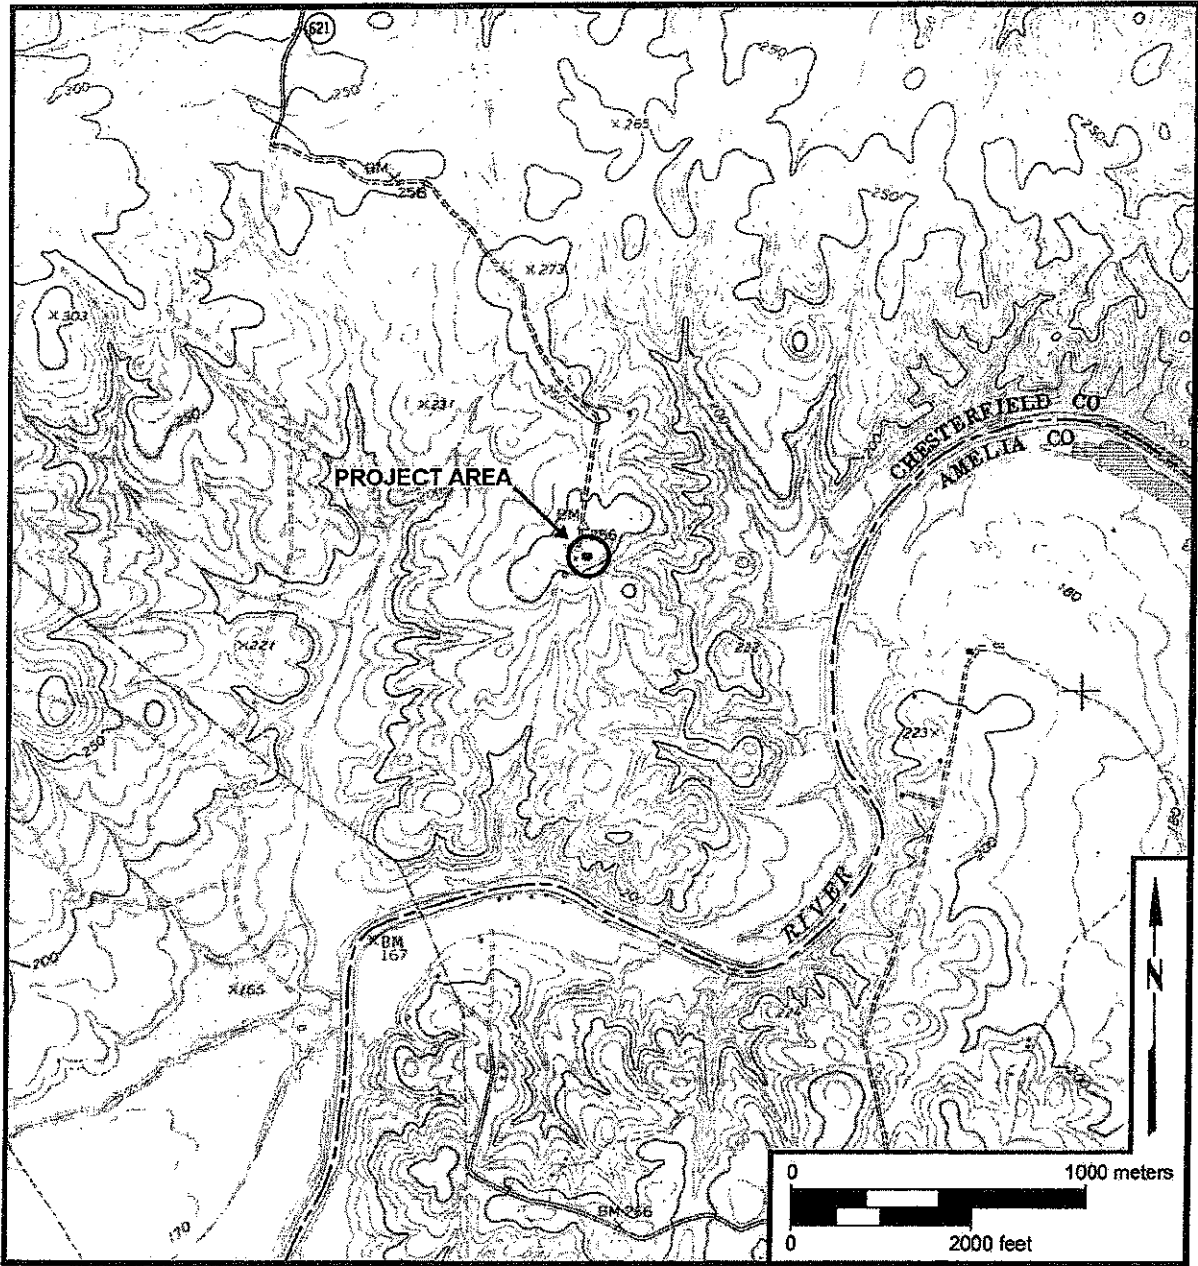
Figure 2. Project area and environs (U.S. Geological Survey 1987).

Archaeological testing was conducted in the schoolhouse/kitchen area immediately west of the west wing of the house and in the basement (Figure 3). One goal of this evaluation was to determine the location of the historically documented schoolhouse/kitchen building. Test unit placement for the schoolhouse/kitchen was based on an 1806 insurance plat (see Fesler 1994:20). According to this document, two outbuildings were located west of the mansion and each structure measured approximately 40 ft. (12.2 m) by 16 ft. (4.9 m) and contained a center chimney. The structure nearest to the west wing (only 17 ft. to the west) is identified as a schoolhouse while the second structure is identified as a kitchen (Figure 4). According to an 1815 insurance plat, the structure known in 1806 as the kitchen had been destroyed, while the schoolhouse building was identified as a kitchen (see Fesler 1994:21; Mutual Assurance Society 1806, 1815) (see Figure 4). A 1796 sketch of Eppington by the renowned architect Benjamin Latrobe also depicts a portion of a gabled structure about the same distance west of the main house as the schoolhouse/kitchen shown on the insurance plats (Latrobe 1977).

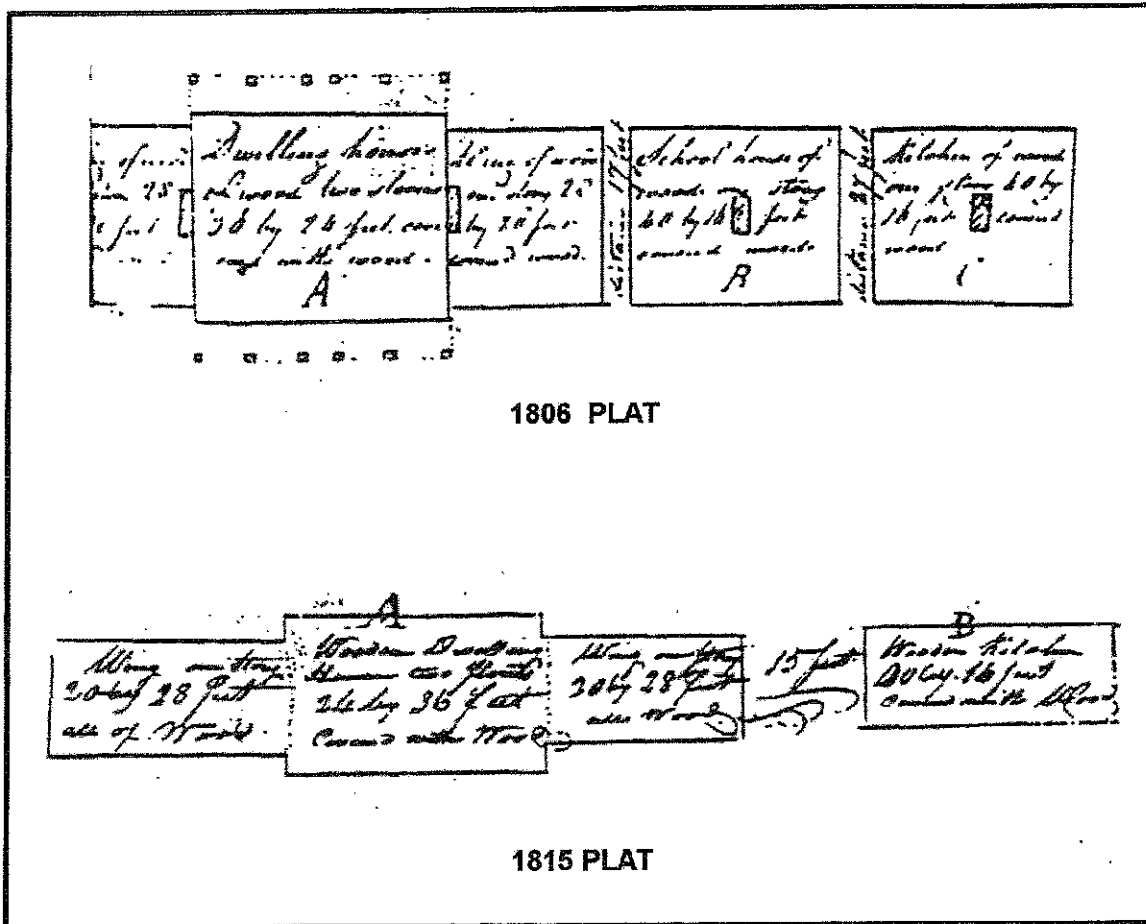
Figure 4. Sketch plans of structures at Eppington from 1806 and 1815 insurance plats (Mutual Assurance Society 1806, 1815).

The building nearest the main house on the west side is indicated first as a schoolhouse by an 1806 insurance plat. On an 1815 plat it was described as a kitchen. Using the very specific distances and dimensions in these documents, it was an easy matter

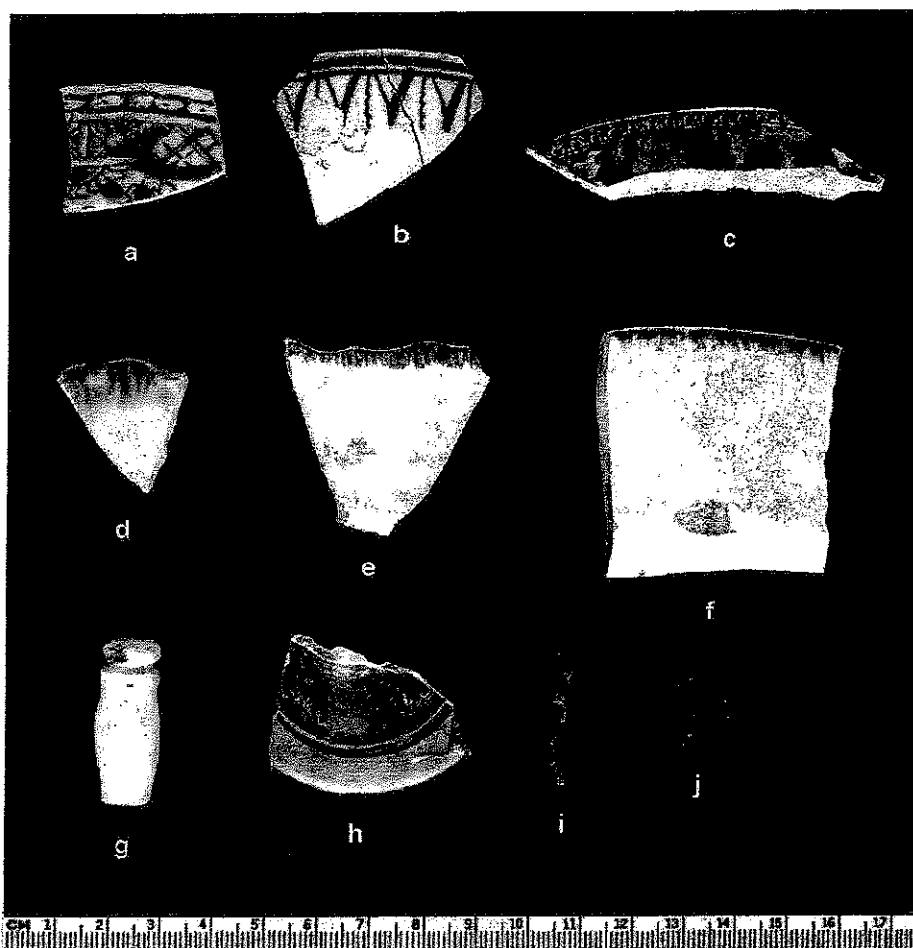
Figure 5. Selected diagnostic artifacts (a - underglaze blue Chinese porcelain plate; b - hand-painted blue pearlware teabowl; c - blue transfer-printed pearlware plate; d - green shell-edge pearlware plate; e - blue shell-edge pearlware plate; f - blue shell-edge whiteware plate; g - porcelain doll part; h - glass stemware base; i - slate pencil; j - jet button [a-c, e, f, h-j - TU27, L.II; d - TU30, L.I; g - TU28, L.II]).

The excavation of six test units and surface collection resulted in the recovery of 1,054 historic artifacts (see Appendix A). Of the total historic assemblage, 43% (n=458) are artifacts associated with food preparation or consumption, 28% (n=299) are architectural artifacts of various types, 18% (n=190) represent unassigned materials, 5% (n=57) are medicinal/hygiene related, the furniture group such as lighting devices represent 2% (n=22), faunal/floral material represents 2% (n=21), and less than 1 % each are activities, clothing, personal, and arms and military items. Also recovered were 586 g of handmade brick fragments, 101.1 g of plaster, 99.8 g of mortar, 23.4 g concrete, 43.5 g of slate, 2 g of oyster shell, 178.4 g of coal/cinders, and 201.7 g of clinker (Table 1). Figure 5 illustrates a small selection of diagnostic artifacts recovered.

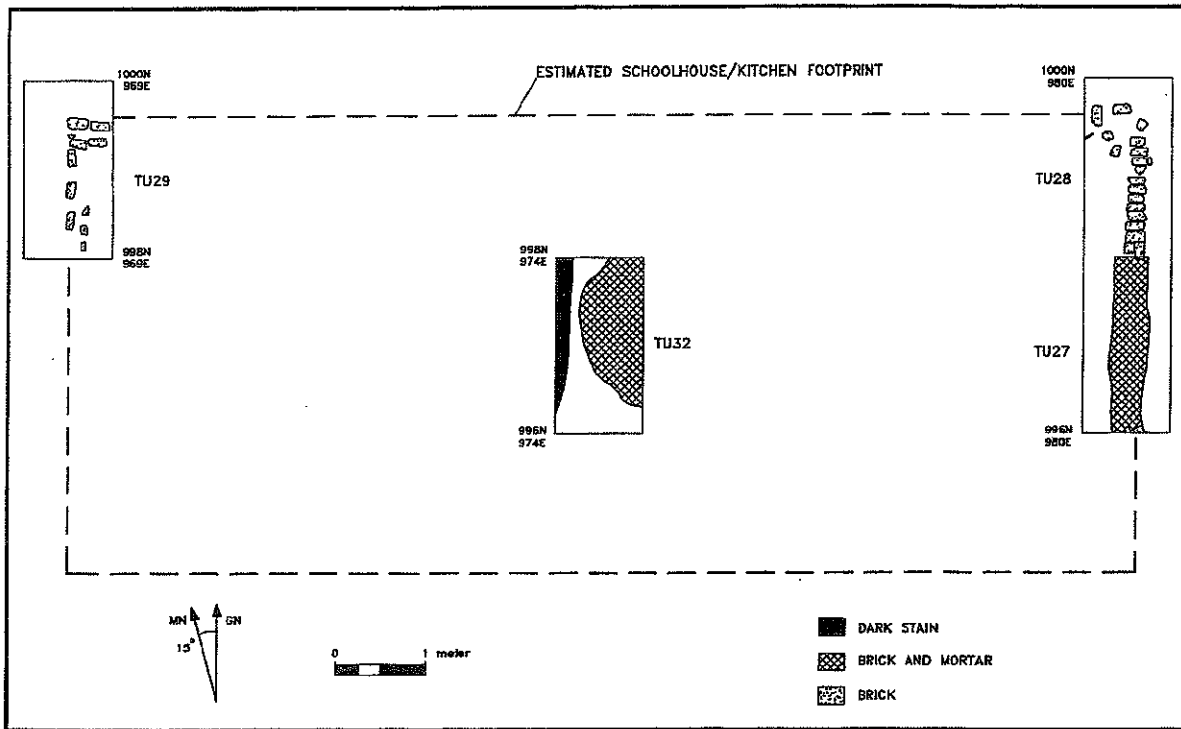
Figure 6. Schoolhouse/kitchen area, plan.

After the removal of 5 cm of soil, a linear feature was identified running north-south. This linear feature consists of brick and mortar fragments and numerous artifacts (Figure 6). This feature is located approximately 17 ft. (5.2 m) west of the west wing. This is the same length given on the 1806 insurance plat for the distance between the west wing and the schoolhouse (see Fesler 1994:20). This feature represents the eastern edge of the schoolhouse/kitchen building. No further excavation was conducted in Test Unit 27; however, photographs were taken and a plan view drawing was made.

While excavating Stratum II, a single row of unmortared bricks was located in situ running north-south including what appeared to be the northeast corner of building (see Figure 6). The northeast corner is also in line with the west wing which is clearly shown on the 1806 insurance plat (see Fesler 1994:20). The row of bricks line up with the linear feature located in Test Unit 27 and represents the eastern edge of the schoolhouse/kitchen building. No further excavation was conducted in Test Unit 28; however, photographs were taken and a plan view drawing was made.

A row of bricks running north-south including a corner was located just below ground surface (see Figure 6). These bricks were not positioned as closely together as the bricks in Test Unit 28 which indicate that some bricks had been removed. The corner represents the northwest corner of the schoolhouse/kitchen. A tape was pulled from the northeast corner to the northwest corner of building and the

cated in the eastern half of unit (see Figure 6). Also, a burned area containing coal and gravel was identified along the west wall of unit at the base of Stratum II. Photographs were taken and a plan view drawing was made.

to locate four 1-x-2-m test units where the footprint of the structure should have been. Guided by the documentary information, excavations defined three of the four sides of the schoolhouse building along with the central chimney location (see Figure 6).

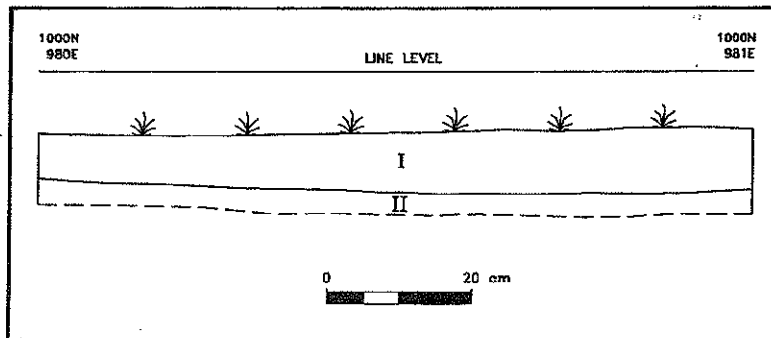
Figure 7. Test Unit 28, north profile.

- I - Dark brown (10YR3/3) silty loam
- II - Dark olive brown (2.5Y3/3) silty loam

Test Unit 28 (1 × 2 m) was placed adjacent the north edge of Test Unit 27 to follow the linear feature in Test Unit 27 in hopes of locating the northeast corner of the building. Stratum I was approximately 6–9 cm thick and consists of dark brown (10YR3/3) silty loam (Figure 7). Artifacts recovered from Stratum I include brick and mortar fragments, one piece of creamware, one piece of pearlware, one piece of porcelain, four pieces of dark green bottle glass (ca. eighteenth through nineteenth century), window glass, two wrought nails, three wire nails, and coal.

Stratum II was distinguished by a dark olive brown (2.5Y3/3) silty loam. Artifacts recovered from
